Weekly Report

2019-11-08

Kim, Hanbeom

Detector Design re-test

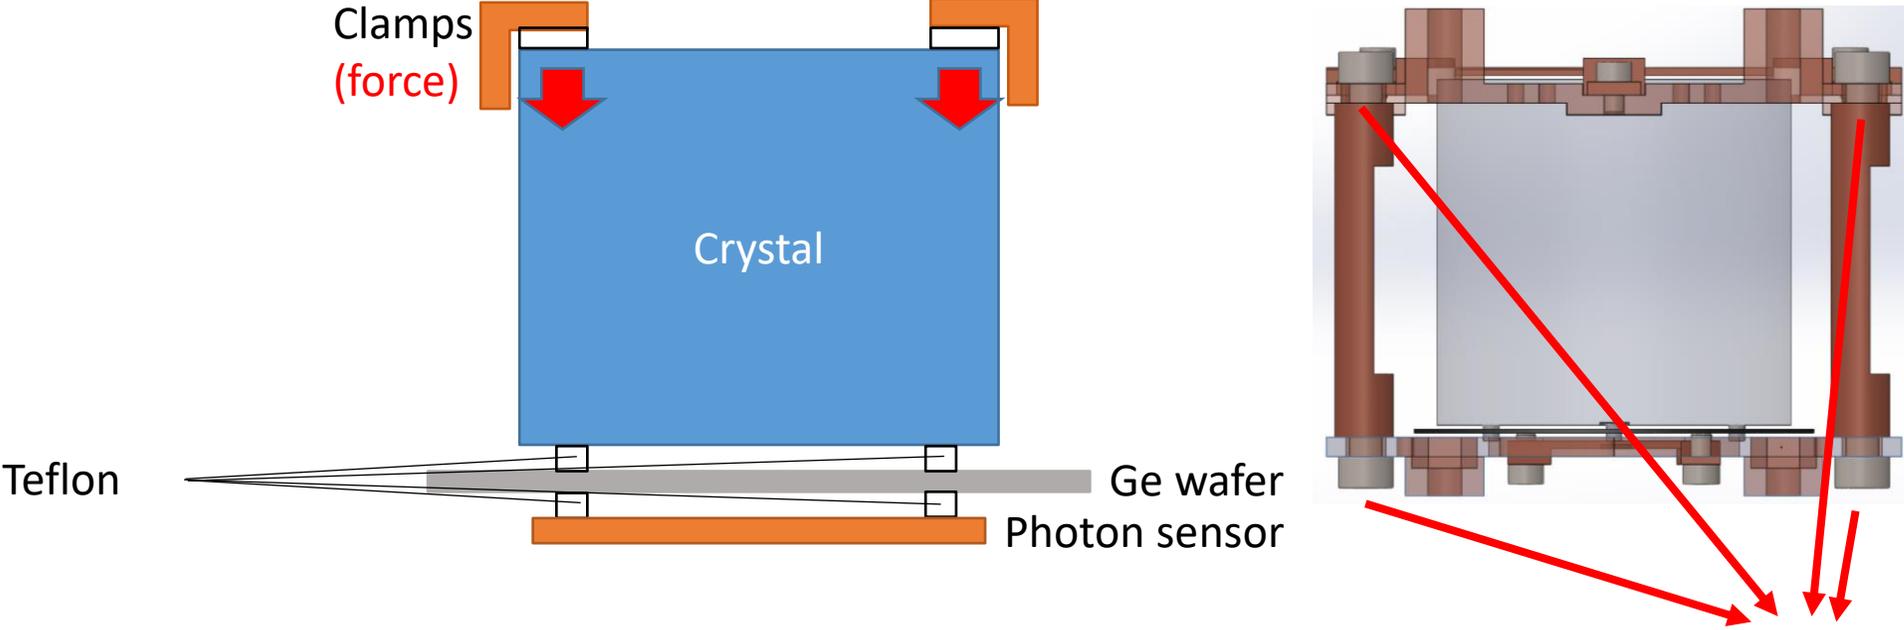
In the last test, there was large temperature fluctuation, expected to be caused by mechanical vibration.
(lack of washers)

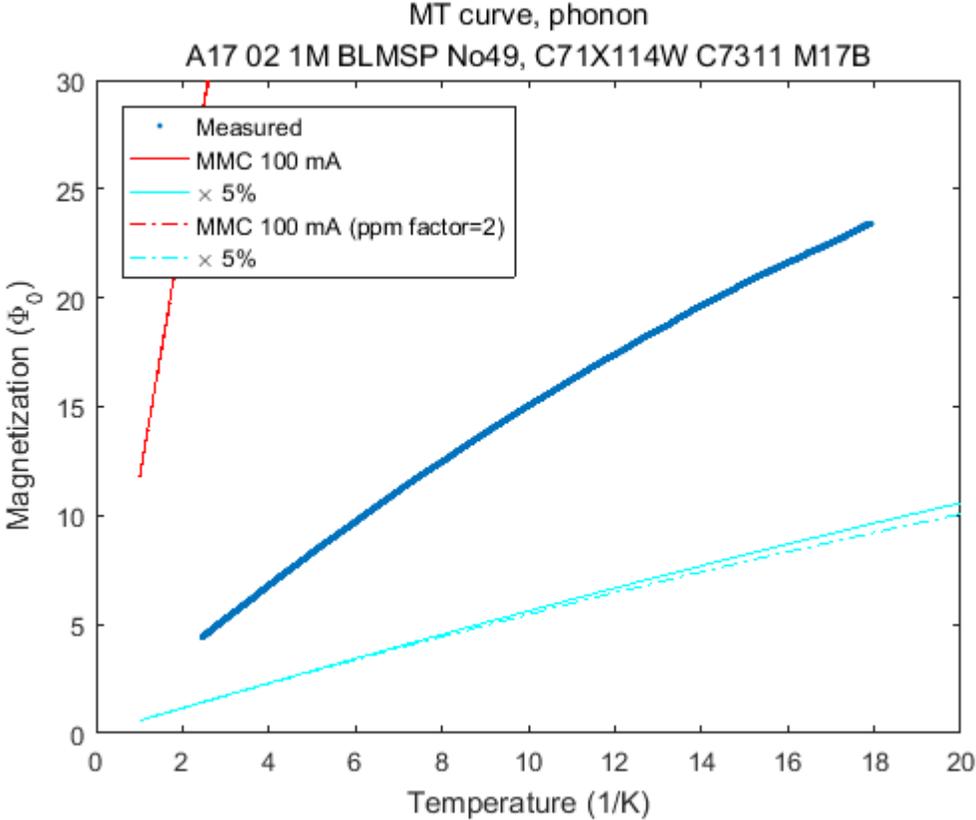
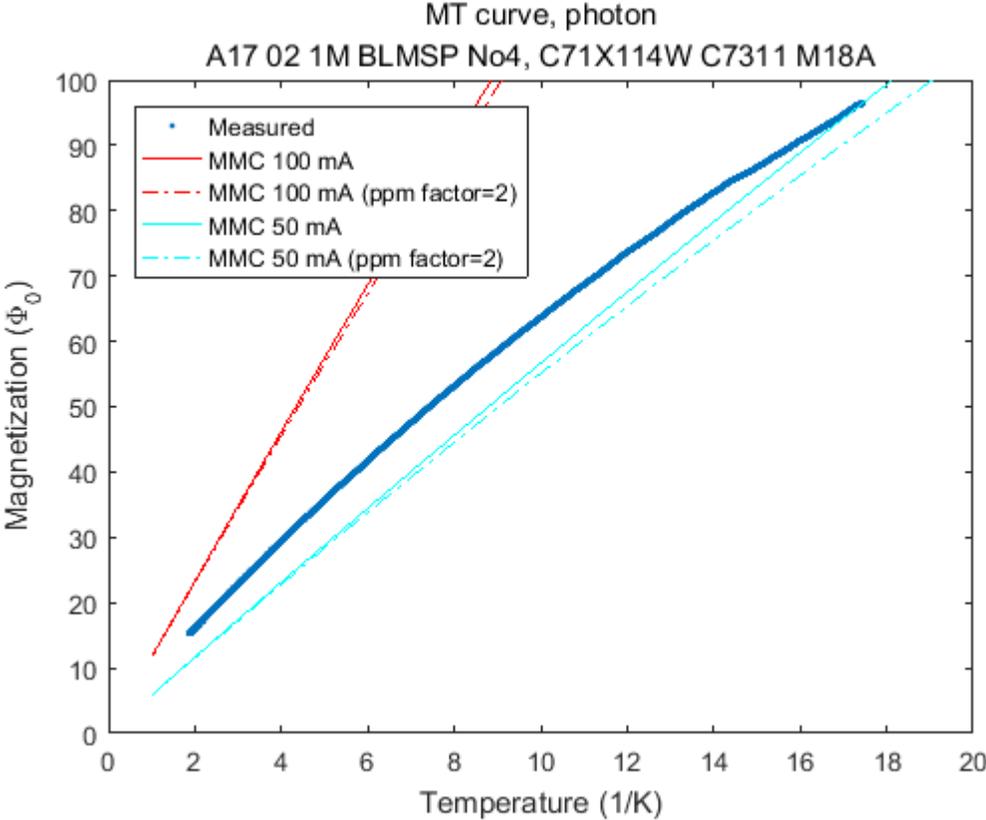
(MMC field current was given 100 mA.)

Current base temperature: ~ 28 mK, but its fluctuation is large

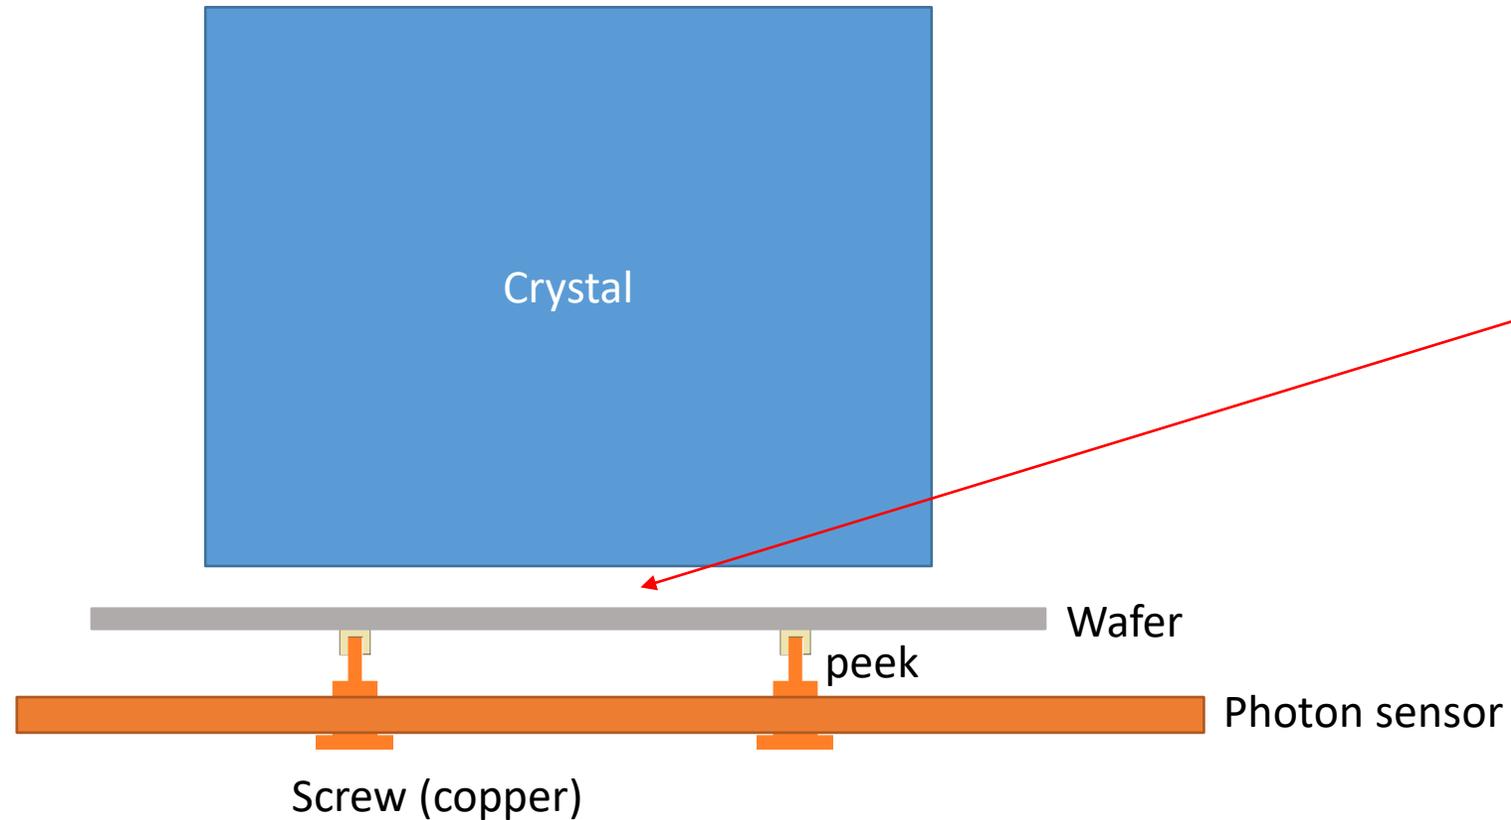
Photon sensor design

Use araldite adhesive to glue
Not connected

1. Thermal contraction
2. (Gold) wiring difficulty

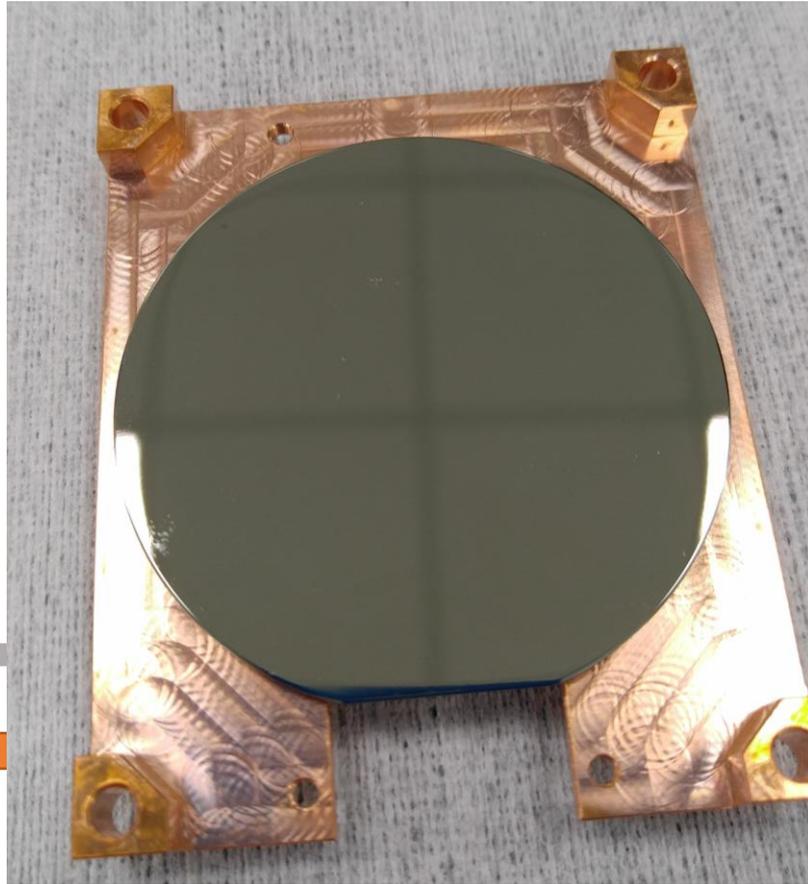
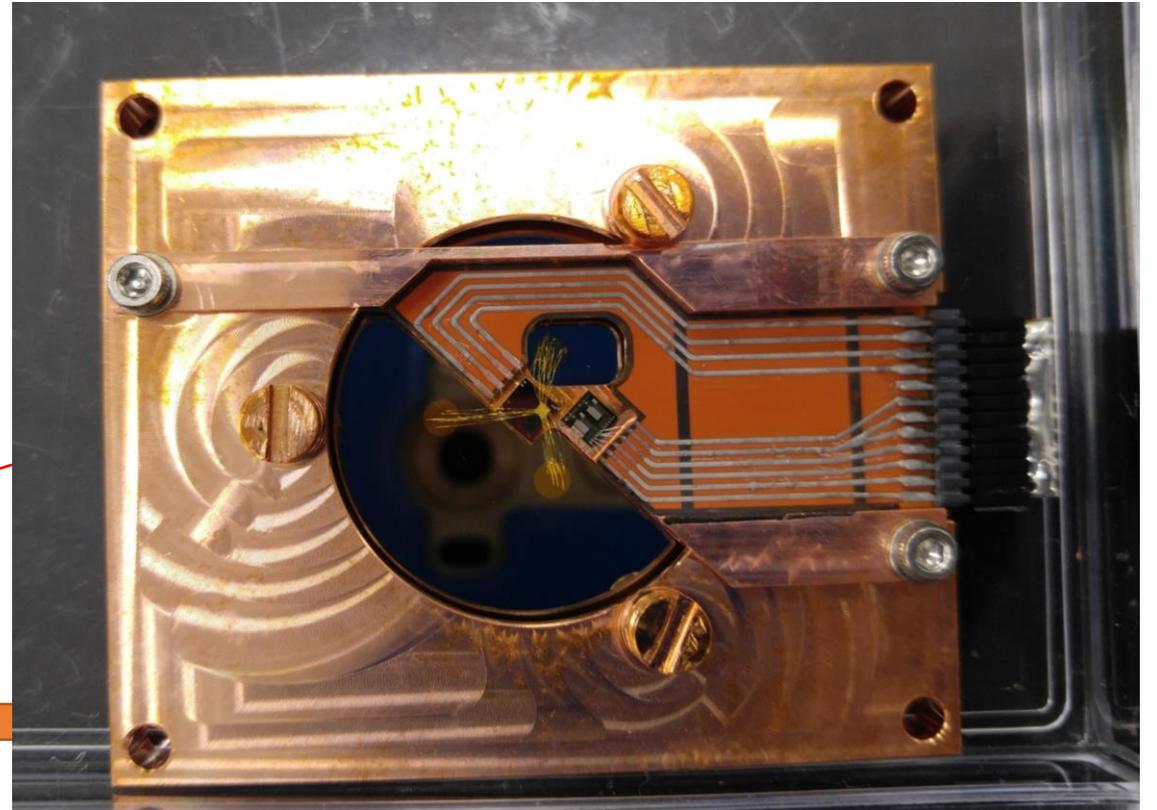
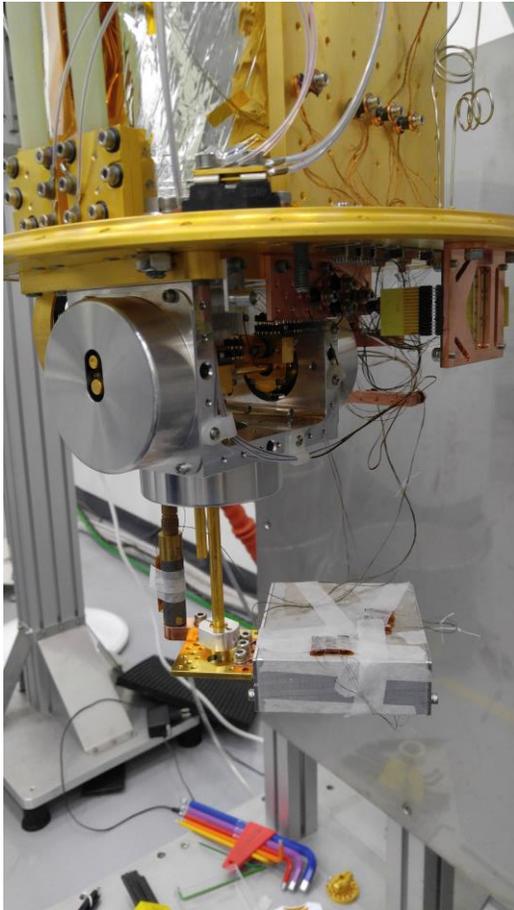
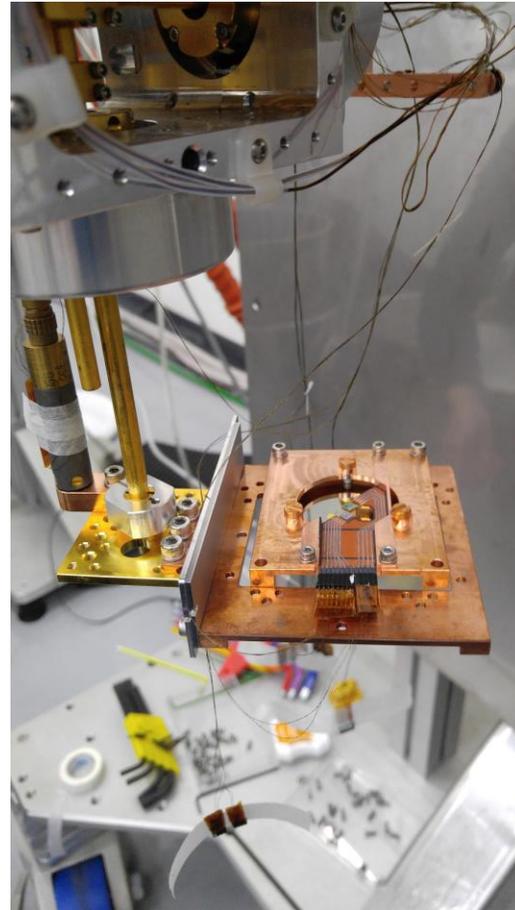
Photon sensor design

11/5:
Installation on ADR & Cooling starts

11/6:
Vibration test
Data collection without PID (Am source)
